Dacia Spring
Standard Safety Equipment

2021

Tested Model	Dacia Spring, electric, LHD
Body Type	- 5 door hatchback
Year Of Publication	2021
Kerb Weight	970kg
VIN From Which Rating Applies	- all Springs
Class	Supermini

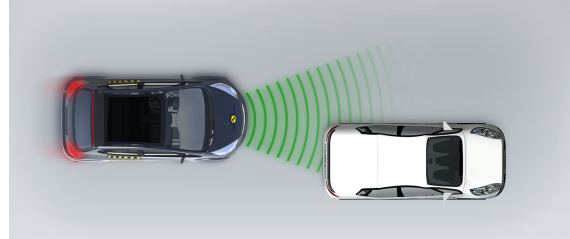
Approaching a stationary car

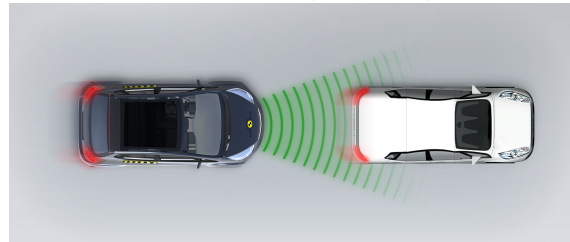
Approaching a braking car

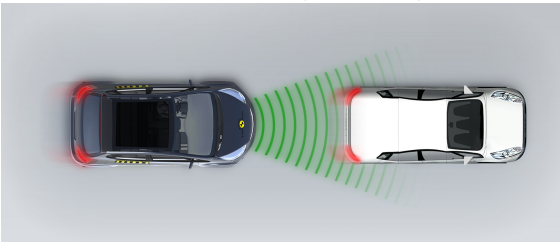
Approaching a braking car
